Genmega/ Hantle PCI EPP Upgrade Paths

Hyosung PCI EPP Upgrade Paths

Triton PCI EPP Upgrade Paths

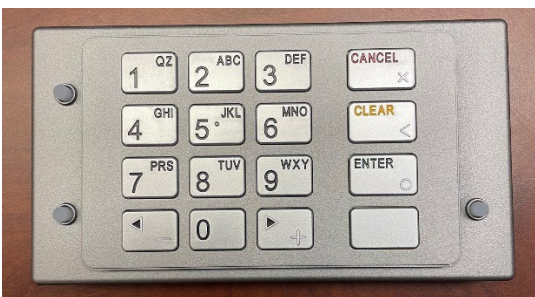
If your keyboard looks like the below photo – with the cancel key at the top right – please look at the backside to ensure it says EPP- B3 or EPP- B5. Pictured below is the compliant EPP-B5.

From the front of the machine- if the keyboard has Enter in the top right – it is not compliant. If it has Cancel in the top right, then look at the backside of the Keyboard. If it says EPP- B1, EPP- B2 – it is a non-compliant keyboard. The ATM will need an upgrade/ replacement based off the previous chart.

If it says EPP-B3 or EPP-B5, it is a compliant keyboard and will only need a software update.

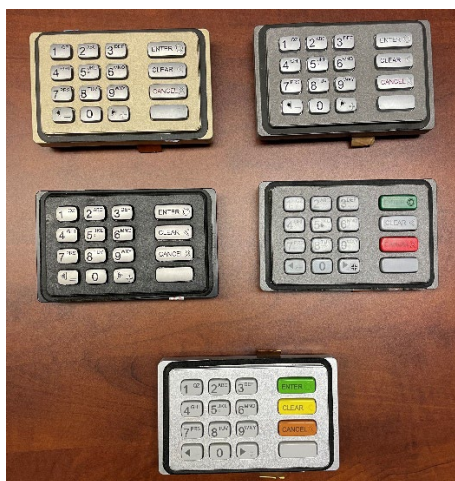
If your keyboards look like the below photo- they are not compliant.

Look at the backside of the Keyboard. If it says 3000K, 5000K, 6000K/R- it is a non compliant keyboard. The ATM will need an upgrade/ replacement based off the previous chart.

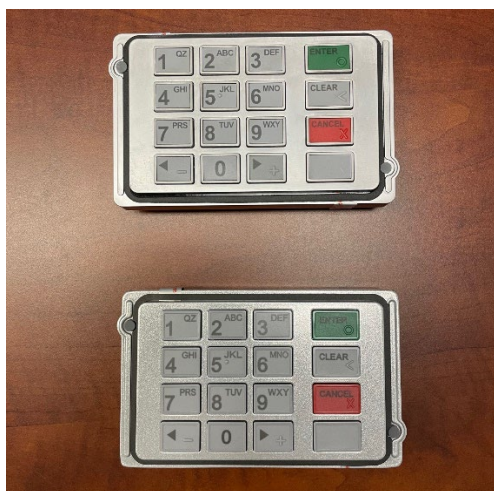
If your keyboards look like the below photo- they are compliant.

If it says 8000R or X-1, it is a compliant keyboard and will only need a software update.
